**SAFETY RECALL: REAR AXLE SUSPENSION COMPONENTS**

Presentation of this letter to your dealer will assist in making the necessary correction in the shortest possible time. Please have your dealer refer to Campaign Bulletin SB00-06-S002.

## Safety Recall: Passport Rear Suspension

00V-058

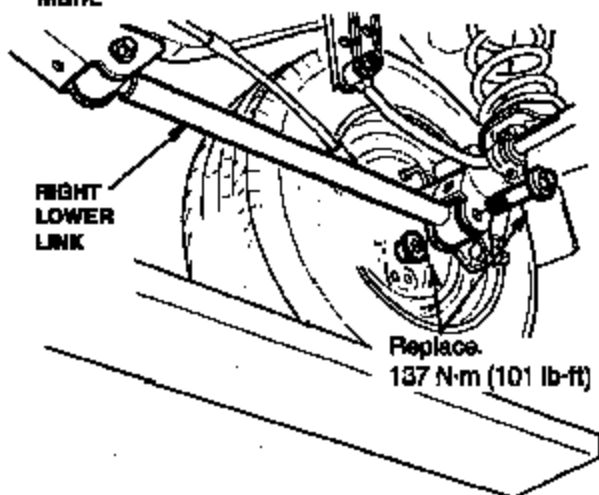
Excessive paint thickness on certain rear suspension components may cause the lower link bolts and nuts to loosen and make noise. Over time, the nut and bolt could fall out, allowing the lower link to separate from the axle.

1. Park the vehicle on level ground. If you need more room underneath, park the vehicle on a wheel alignment rack. Do not raise the vehicle on a hoist, the full weight of the vehicle must be sitting on the suspension during this procedure.
2. Replace the nut and bolt mounting the right lower link to the rear axle. Torque the new nut to 137 N·m (101 lb-ft). Mark the nut and bolt with the Brite-Mark.
